## STS-107 FLIGHT READINESS REVIEW

# BACKUP INFORMATION

# STS-109 PREVIOUS FLIGHT ANOMALIES BACKUP

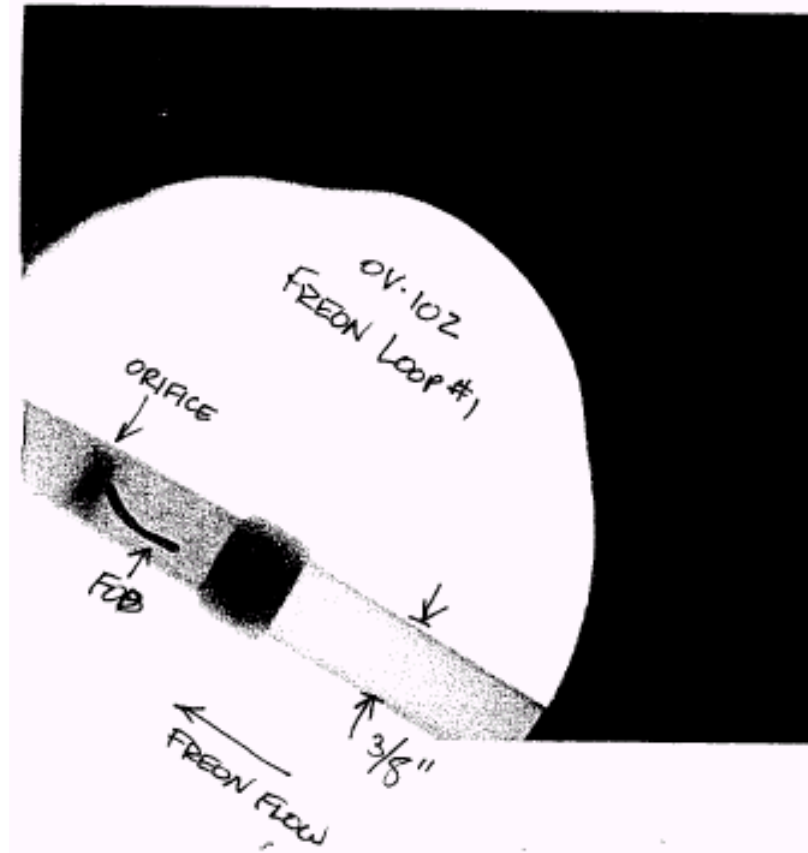
- Approximately ten minutes after lift-off, the FCL 1 ACP flow rate dropped from 305 lbs/hr to 225 lbs/hr, then to 195 lbs/hr when the FCL was reconfigured to rad flow
  - Data review confirmed that the flow reduction was caused by a restriction in the ACP leg
- The flow rate stabilized, and analysis determined that adequate flow would still be available to provide sufficient cooling for the remainder of STS-109

**Braze Preform Debris Found in the Upstream Side of  
the Orifice Between the FES and the Aft Coldplate  
Network**

- During post-flight troubleshooting, a piece of debris was found stuck in the upstream side of the orifice between the FES and the aft coldplate network
- FCL 1 was de-serviced and de-brazed to allow extraction of the contaminant
  - Laboratory analysis confirmed that segment of braze preform became detached during brazing
- More x-rays were taken at other suspected locations after power-down to ensure no additional FOD is present in either loop 1 or 2 (see next slides)
  - Included x-rays of three potential traps in the RFCAs
- Visual inspections of FCL 1 FPM & pump inlet filters were also performed
  - FPM 1 and pump inlet filters replaced

- The debris that caused the flow restriction was removed
- Additional x-rays taken at potential debris traps in both loops and visual inspection of FCL 1 FPM & pump inlet filters verified acceptable system cleanliness
  - FPM 1 and pump inlet filters replaced
- Freon systems have been verified through OMRSD testing

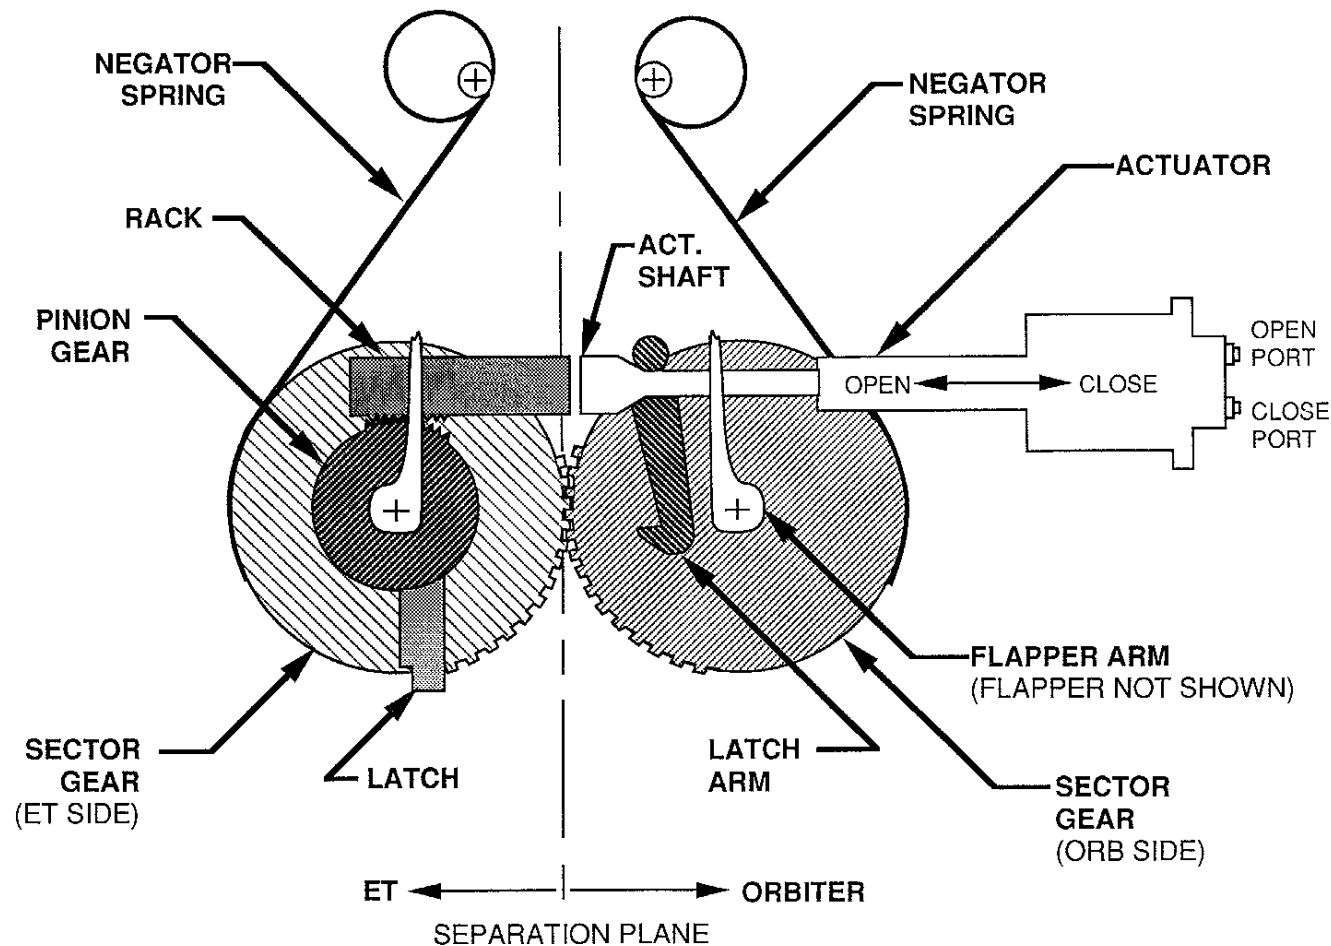
- MPS LH2 4" disconnect failed to close pneumatically when commanded at MECO
  - Closed via back-up mechanical mode at ET/Orbiter umbilical separation

- Inspection of Orbiter disconnect post-landing for indications of failure
  - Initial runway inspection revealed nothing unusual
  - Borescope inspection found Flourogold spacer (spool which negator spring slides/rotates on) cut and bent in towards springs
    - Scuff mark found on back of housing
- Disconnect R&R complete
  - Borescoped new disconnect and verified no damage
  - Leak checks complete and good
  - Removed PD3 failure analysis to follow
    - Ambient & cryo cycle tests

- Disconnect failure to close pneumatically is only critical for uncontained SSME shutdown
  - Probability of SSME catastrophic shutdown is remote
- Borescoped new disconnect and verified no damage
- OMRS verification of disconnect function accomplished prior to propellant loading
- No history of disconnect failure to close via mechanical back-up separation mode
  - Prevents helium loss during entry

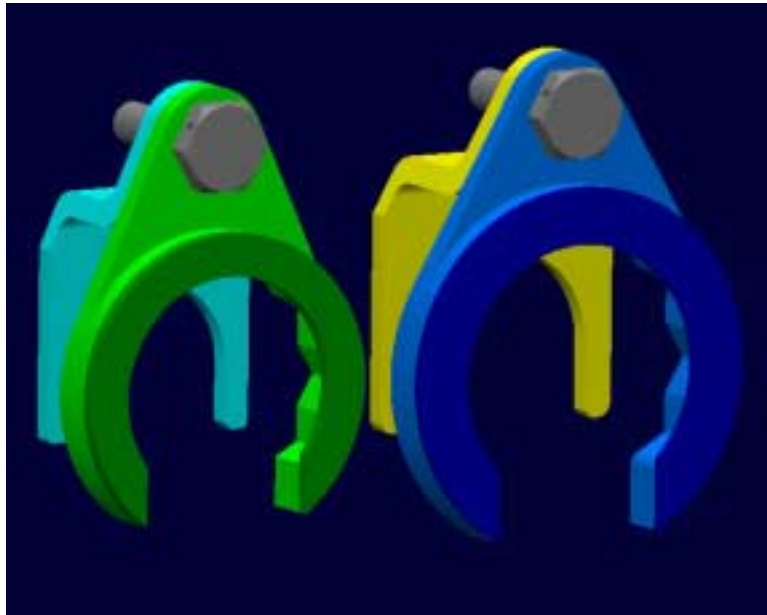
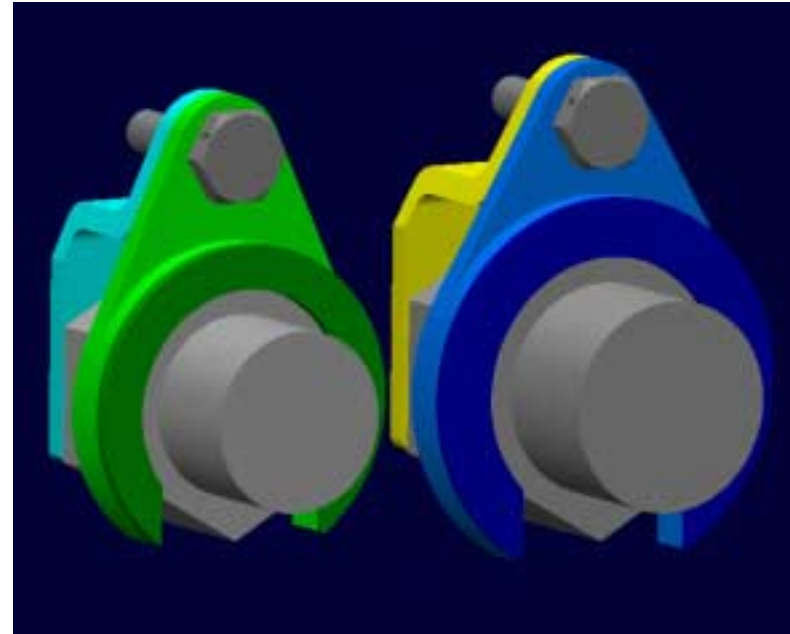
## FRCS Dynatube B-nut Retainers Installed by MR: (Cont)

- Low “break-away” torques noted on LP01 (OV-103) thruster Dynatube fittings lead to pre-load relaxation concern
  - Seal saver from L1A found damaged due to incorrect installation
- OMS/RCS PRT recommended removal of FRC2 to install retainers, ultimately to protect against joint separation due to an improperly installed seal saver
  - FRC2 is only pod/module without safety wire on thruster Dynatube fittings
- Retainers were designed to capture Dynatube fittings with provision for installation of safety cable
- Stress/Dynamics assessment verified acceptability for flight
- FRC2 to be modified to OV-103 & subs safety-wire configuration at next OMDP

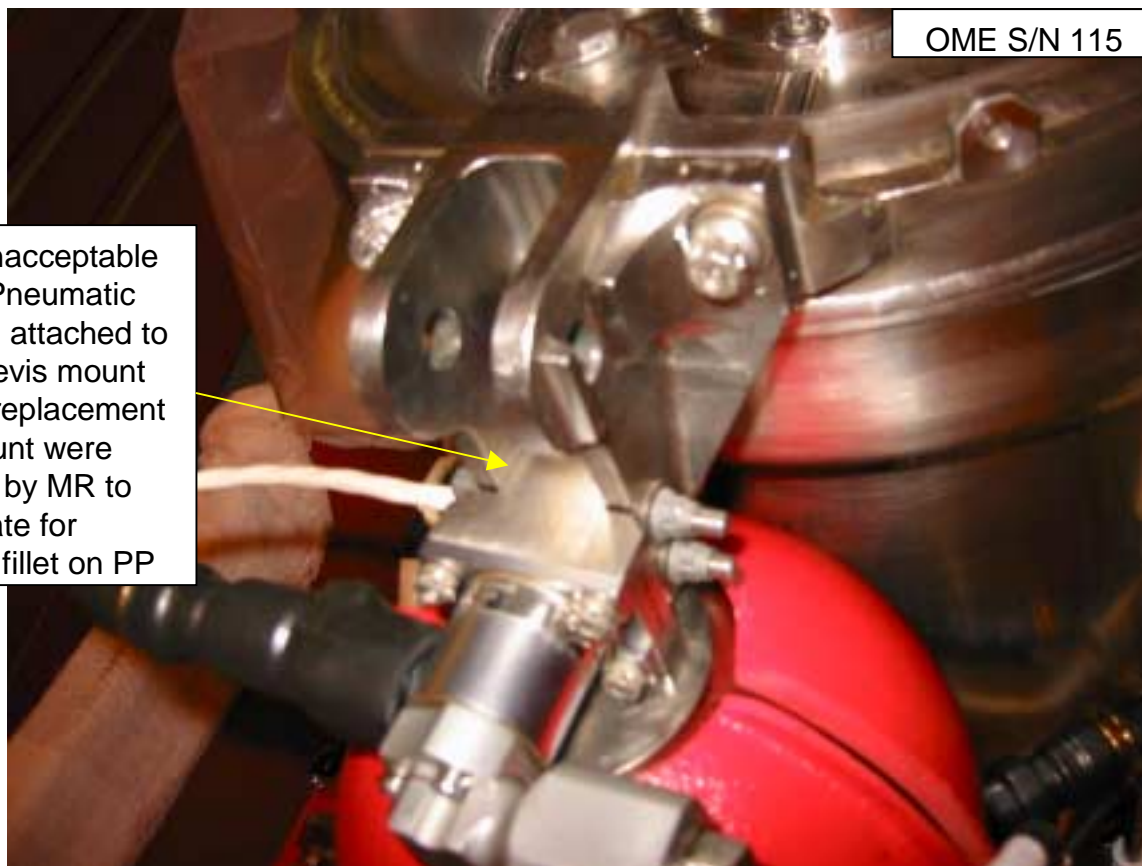
## OME Pitch Clevis Mount (Actuator Not Installed)

- Original clevis mount on Orbital Maneuvering Engine (OME) S/N 116 not manufactured per print
  - The area where the pneumatic pack bracket attaches via two thru-bolts was inadvertently machined ~.021" oversize
  - PRT recommended replacement due to concerns with excessive play in the pneumatic pack bracket attachment and thinning of the clevis where it was machined
  - Replacement part was obtained from WSTF
- With new clevis mount installed, the pneumatic pack could not be attached due to misalignment of the bolt holes
  - Pneumatic pack attach structure also not per print - fillet radius too large, causing clevis mount tangs to contact fillet before bolt holes are in alignment

- Area of unacceptable gap with Pneumatic Pack (PP) attached to original clevis mount
- Tangs of replacement clevis mount were machined by MR to compensate for oversized fillet on PP

- Plan was developed to machine clevis tangs to compensate for oversized fillet (chamfer 0.08" off edges)
- Boeing/JSC Stress verified integrity of the clevis mount is not adversely affected
  - Chamfer does not protrude into bolt holes
- Measurements of both the removed part and the replacement part verified acceptable difference in pitch actuator mounting hole location without adjustment of actuator
- Travel and Response and Heat Shield Clearance checks were performed during OMS/RCS Flight Control Checkout (OMI V1238) with no anomalies

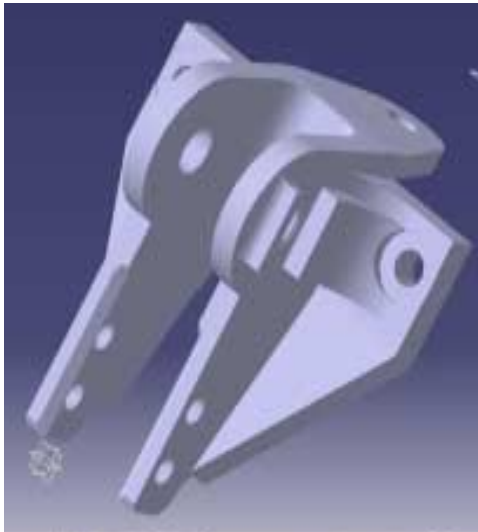
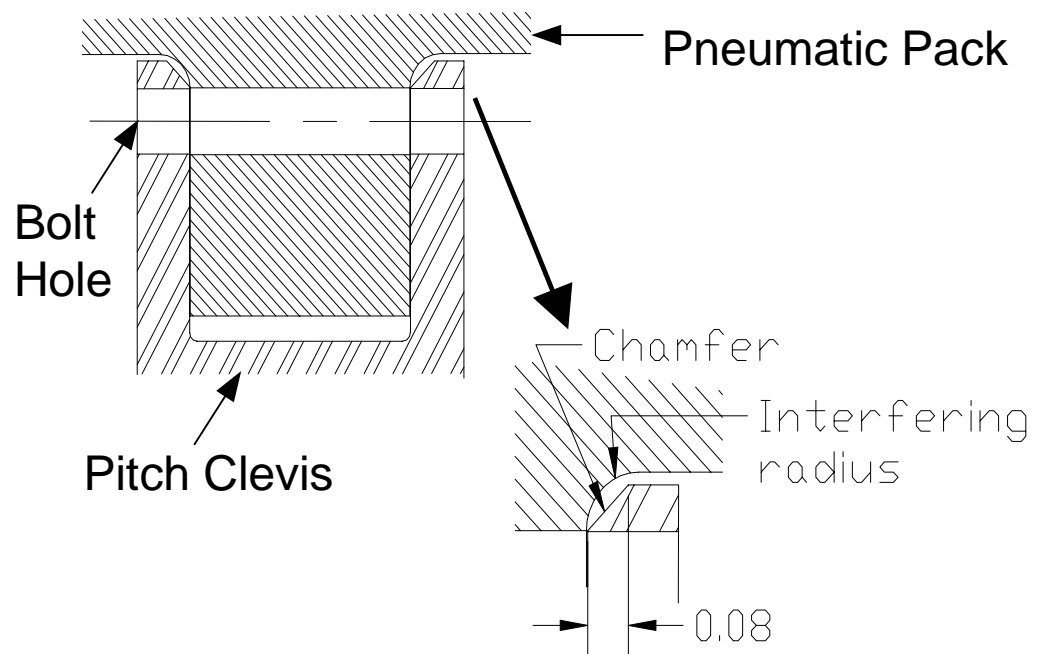
## Modified (Chamfered) OMS Engine Pitch Clevis

Top view of pitch clevis modification  
OMS engine S/N 116
